**Watershed Diagnostic Study for:
Pipe Creek-Potter Ditch
Little Pipe Creek, Sugar Creek, and
Honey Creek Subwatersheds**

October 2003

Indiana Department of Natural Resources, Division of Soil Conservation Field Staff
Howard County Soil and Water Conservation District Staff
Commonwealth Biomonitoring

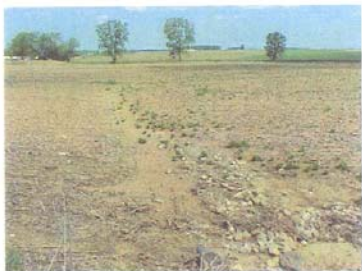
Gully erosion
T25N, R6E, sec 16
Grant County

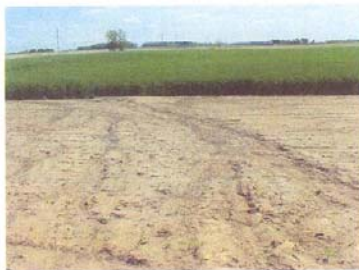
Rill erosion
T 25N, R6E, sec 21
Grant County

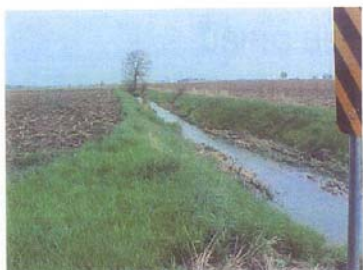
Lack of vegetative buffer
Honey Creek
Howard County

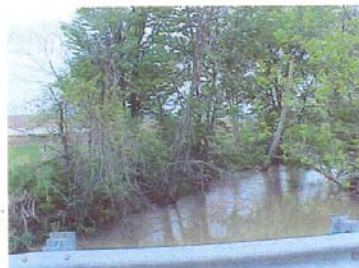
Poor riparian buffer
Pipe Creek
Miami County

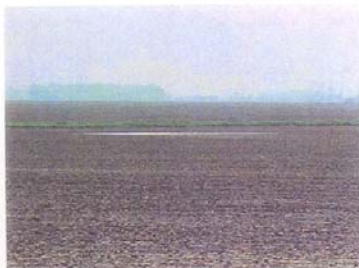
Potential wetland restoration site
CR 1100 E, north of CR 200 N
Howard County, Sugar Creek watershed

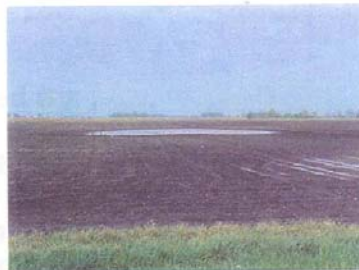
Potential wetland restoration site
CR 1200 E, north of CR 400 N
Howard County, Sugar Creek watershed

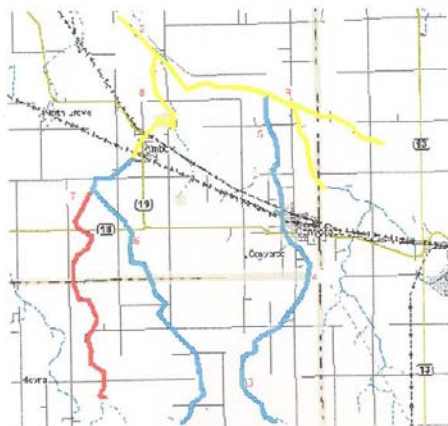
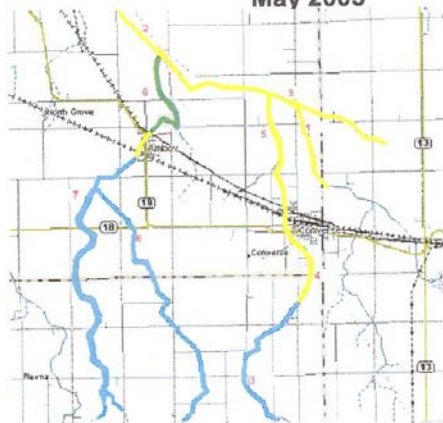
Figure 5.
Biological Impairment in the Pipe Creek Watershed
Green = None Yellow = Slight
Blue = Moderate Red = Severe
